**DEPARTMENT OF TRANSPORTATION****DIVISION OF ENGINEERING SERVICES**

Contract #: 04-0120F4Cty: SF/ALA Rte: 80 PM: 13.2/13.9File #: 69.28**WELDING INSPECTION REPORT****Resident Engineer:** Pursell, Gary**Address:** 333 Burma Road**City:** Oakland, CA 94607**Report No:** WIR-016071**Date Inspected:** 08-Aug-2010**Project Name:** SAS Superstructure**OSM Arrival Time:** 700**Prime Contractor:** American Bridge/Fluor Enterprises, a JV**OSM Departure Time:** 1900**Contractor:** Zhenhua Port Machinery Company, Ltd (ZPMC), Changxing Island **Location:** Shanghai, China**CWI Name:** Huang Min.**CWI Present:** Yes No**Inspected CWI report:** Yes No N/A**Rod Oven in Use:** Yes No N/A**Electrode to specification:** Yes No N/A**Weld Procedures Followed:** Yes No N/A**Qualified Welders:** Yes No N/A**Verified Joint Fit-up:** Yes No N/A**Approved Drawings:** Yes No N/A**Approved WPS:** Yes No N/A**Delayed / Cancelled:** Yes No N/A**Bridge No:** 34-0006**Component:** OBG components.**Summary of Items Observed:**

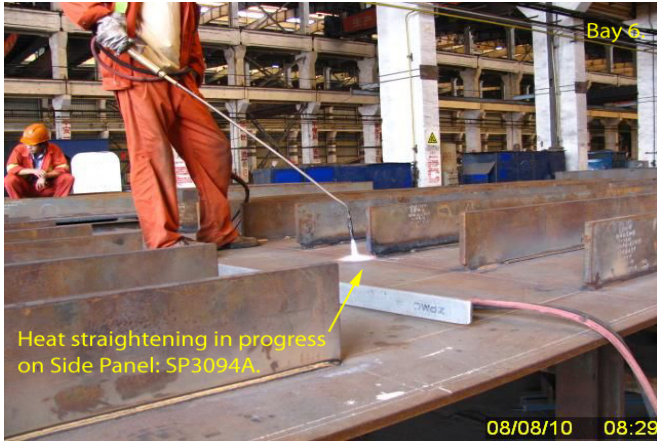
This QA Inspector observed ZPMC personnel performing the heat straightening operation on Side Panel SP3094A. The Heat Straightening was performed according to Heat Straightening Request (HSR) no: HSR1(B)-8988 Rev-0, Dated: 08/05/10. The ZPMC QC is identified as Shu Yang Hua. HSR was performed to correct the weld distortion on the Side Panel. See attached photo for further details.

The Submerged Arc Welding (SAW) process on weld joint no: BK004A1-064-009 (after back - gouging). The welder is identified as 040831 and was observed welding in the 1G position. ZPMC QC was identified as Liu Fa Wen. The welding variables recorded by QC appeared to comply with WPS: B-T-2221-L2c-S-2. See attached photo for further details.
